# The opening of the two Road Corridors in Angola

**C H Eriksson  
G Möller**

**Sida Evaluation 96/37  
Department for  
Infrastructure and  
Economic Cooperation**

Authors: C H Eriksson G Möller  
STT & Transport Consultants AB

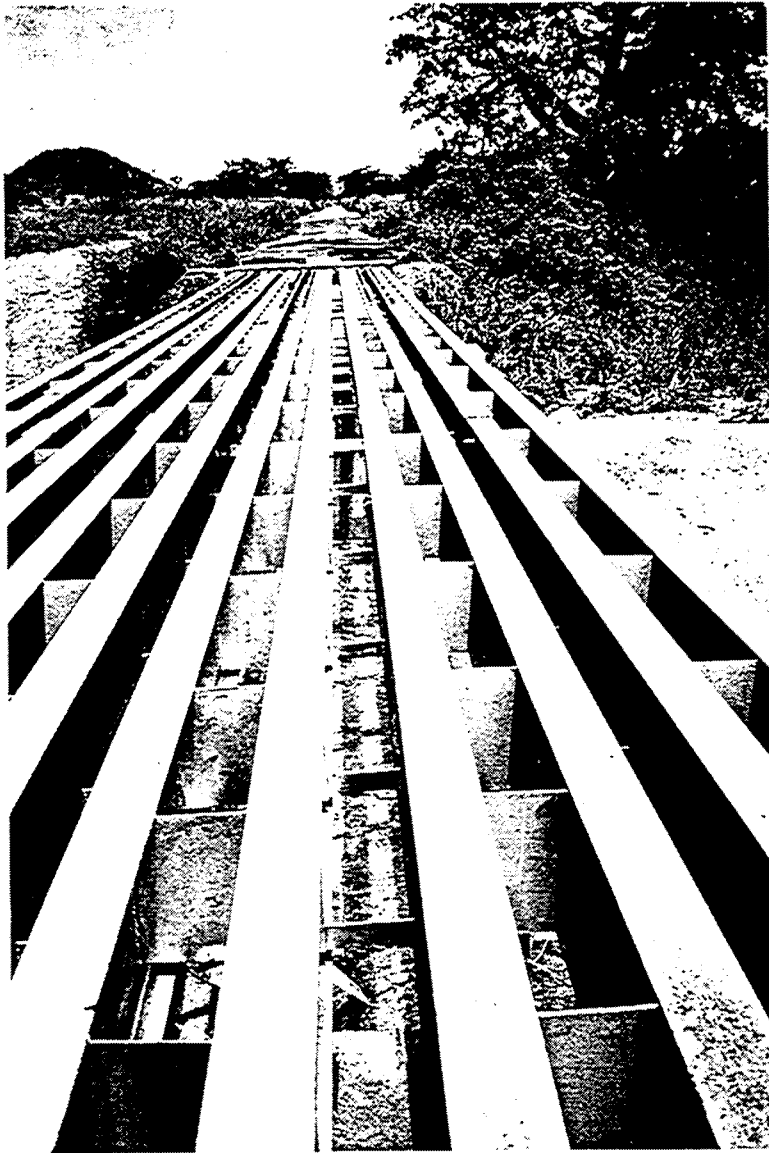
**Luanda-Malange**  
**Rio Subo**  
Permanent composite  
steel-concrete bridge,  
and temporary bridge  
Russian type

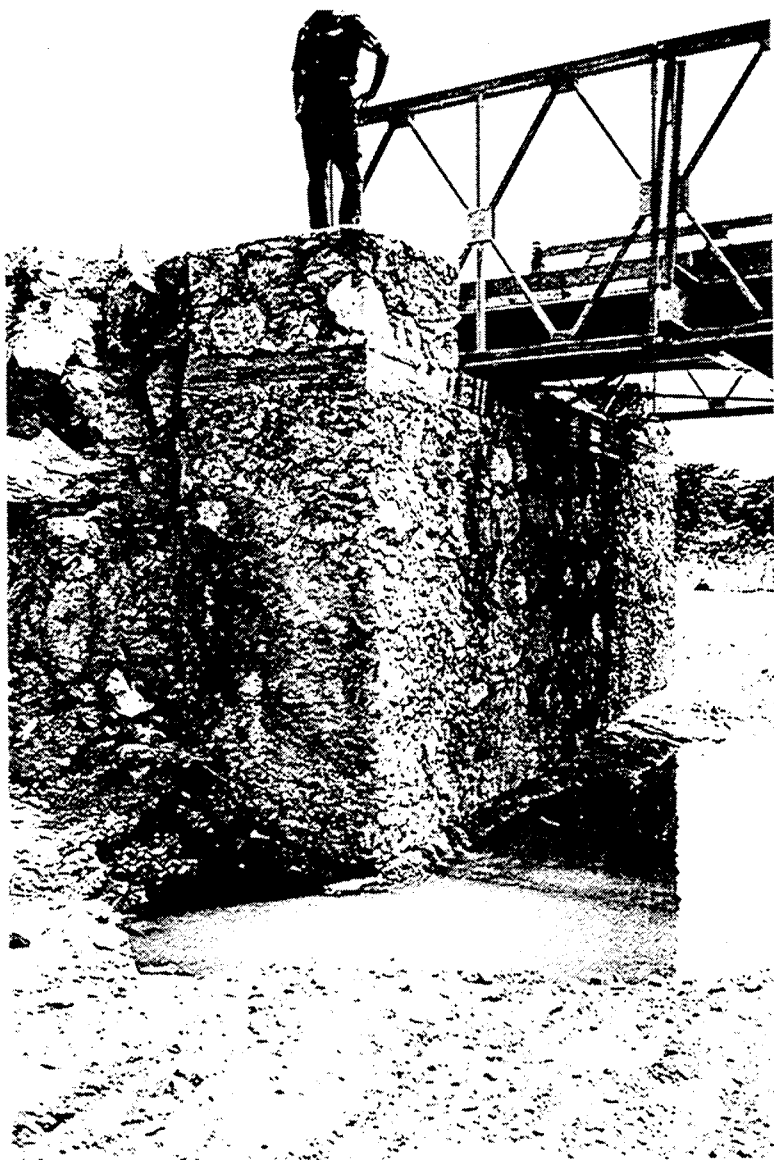
Luanda-Malange  
Rio Mucoso  
Erosion damage at  
one abutment

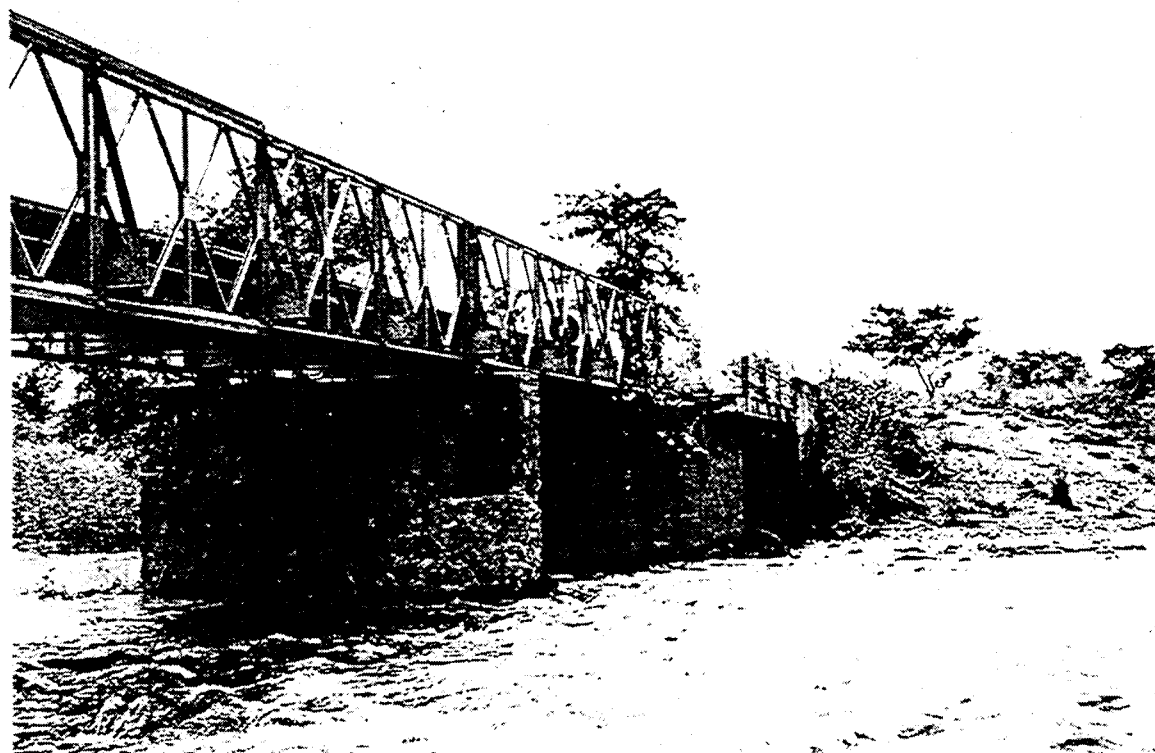
Luanda-Malange  
Rio Lucala 1  
Destroyed railway bridge

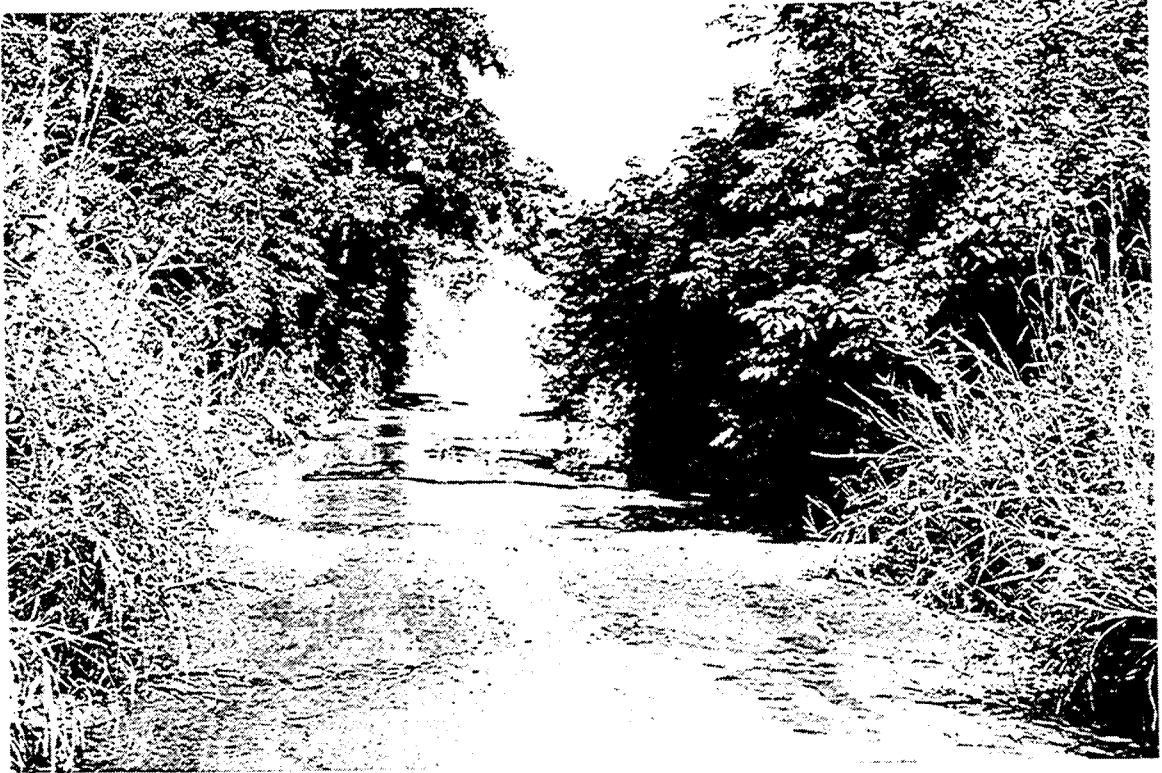
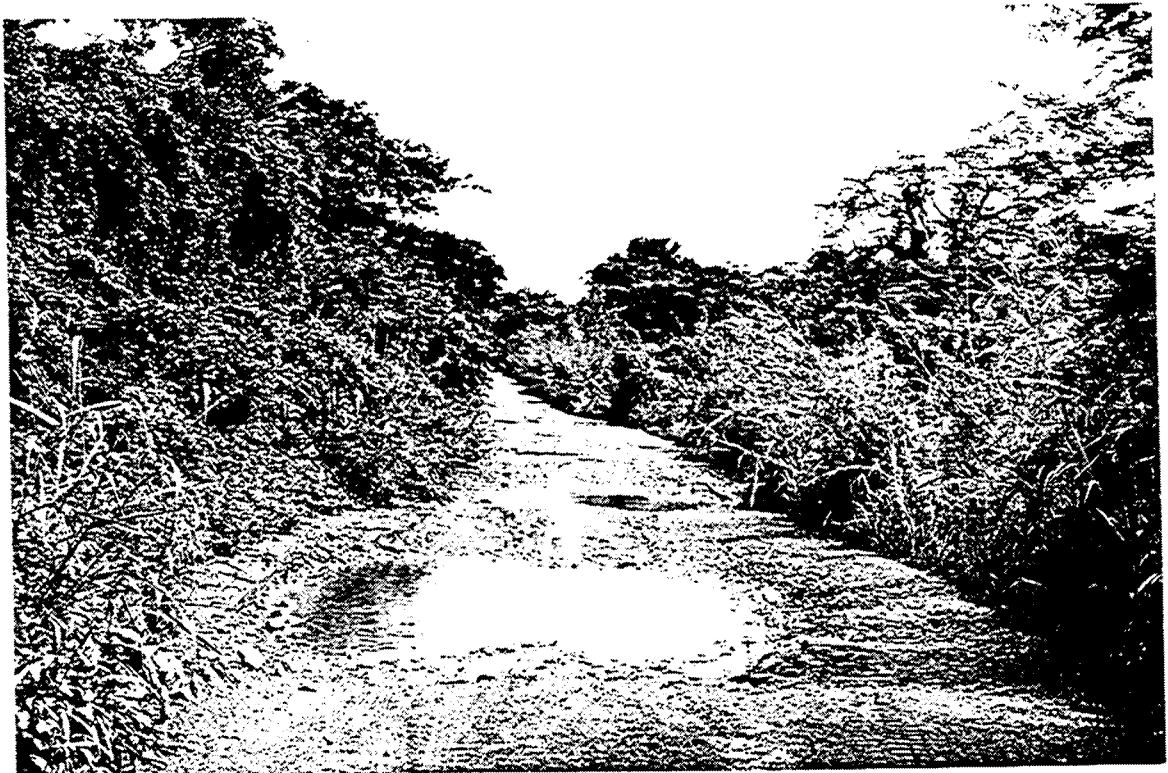
Zenza-Dondo section  
Road in bad condition

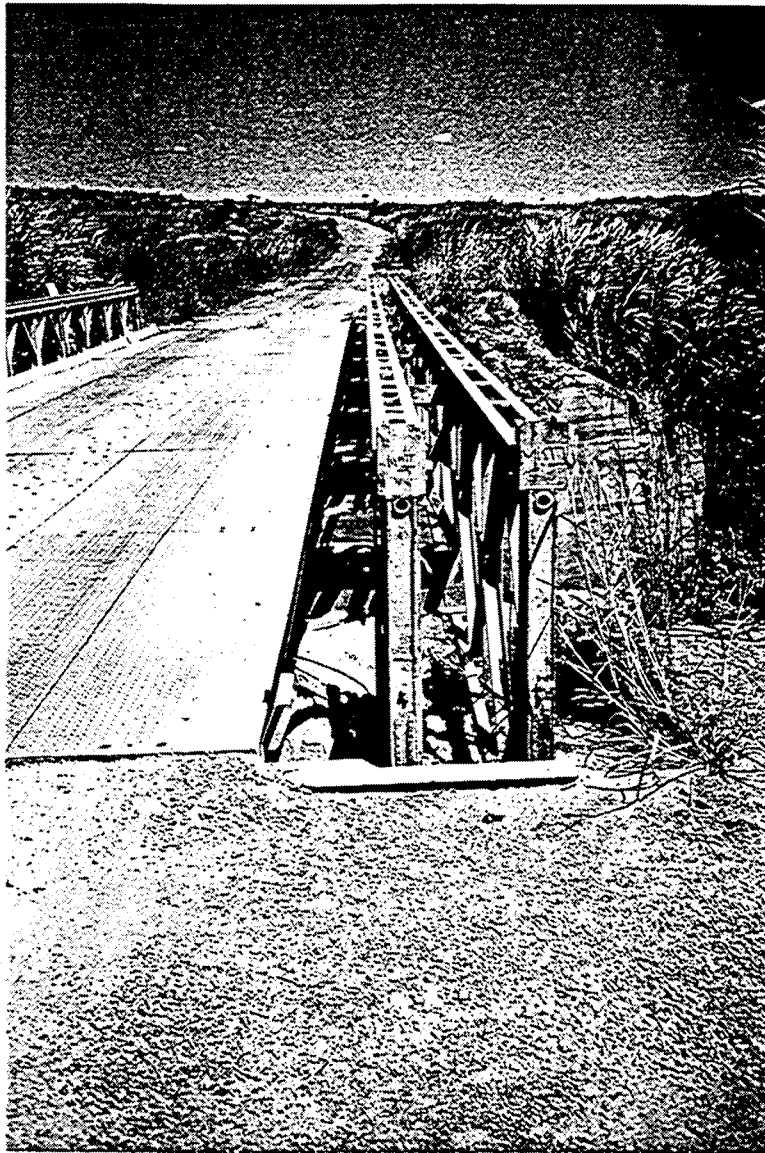
The bridge has one span of 36.0 metres and is of type DSR1 - C200. The bridge was completed by end November 1995. Some adjustments should be made; end bracings are missing and should be placed without delay; only three bracing boxes between the top chords, additional should be placed; some bolts between top chord profiles are loose and should be tightened. The road approaches are in bad shape. In the design of the new permanent bridge, the required bridge opening shall be determined by hydraulic calculations. It was noticed that the latest destroyed permanent bridge at a new location had been constructed much longer than the original bridge.

**Huambo-Kuito**  
**Rio Cuchi**  
Missing end and top  
bracings

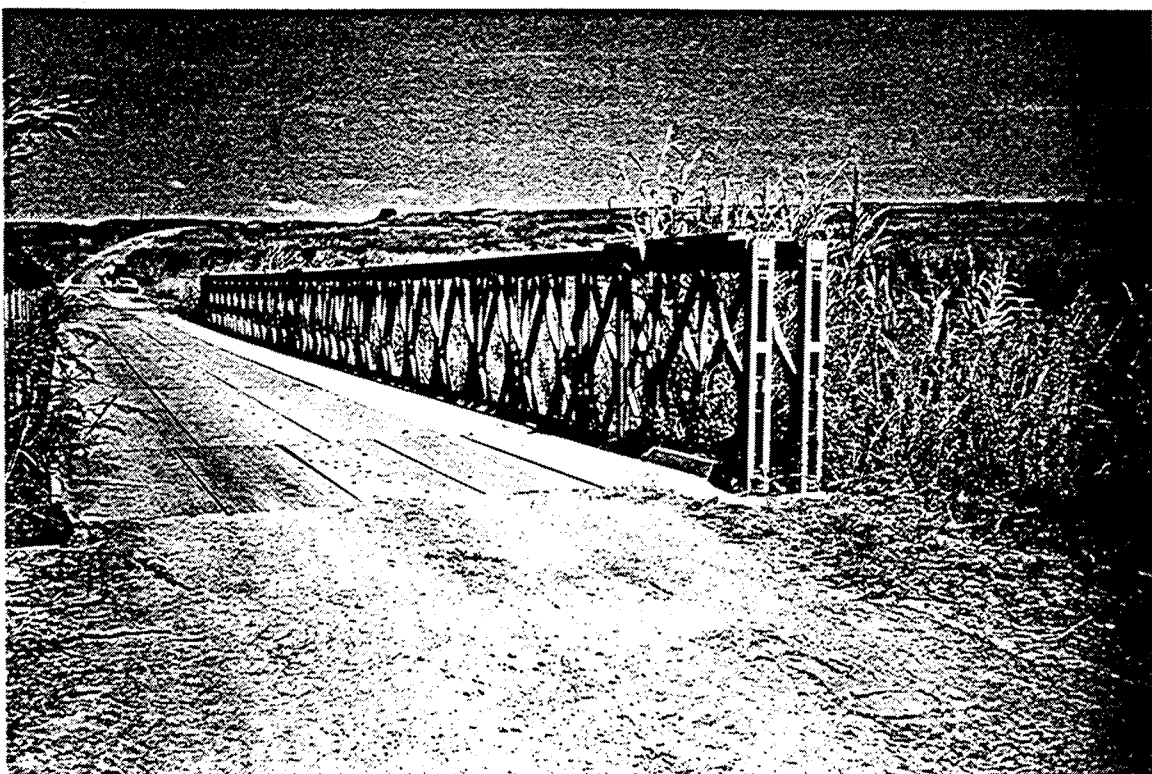
**Huambo-Kuito**  
Destroyed permanent bridge at Rio Cutato

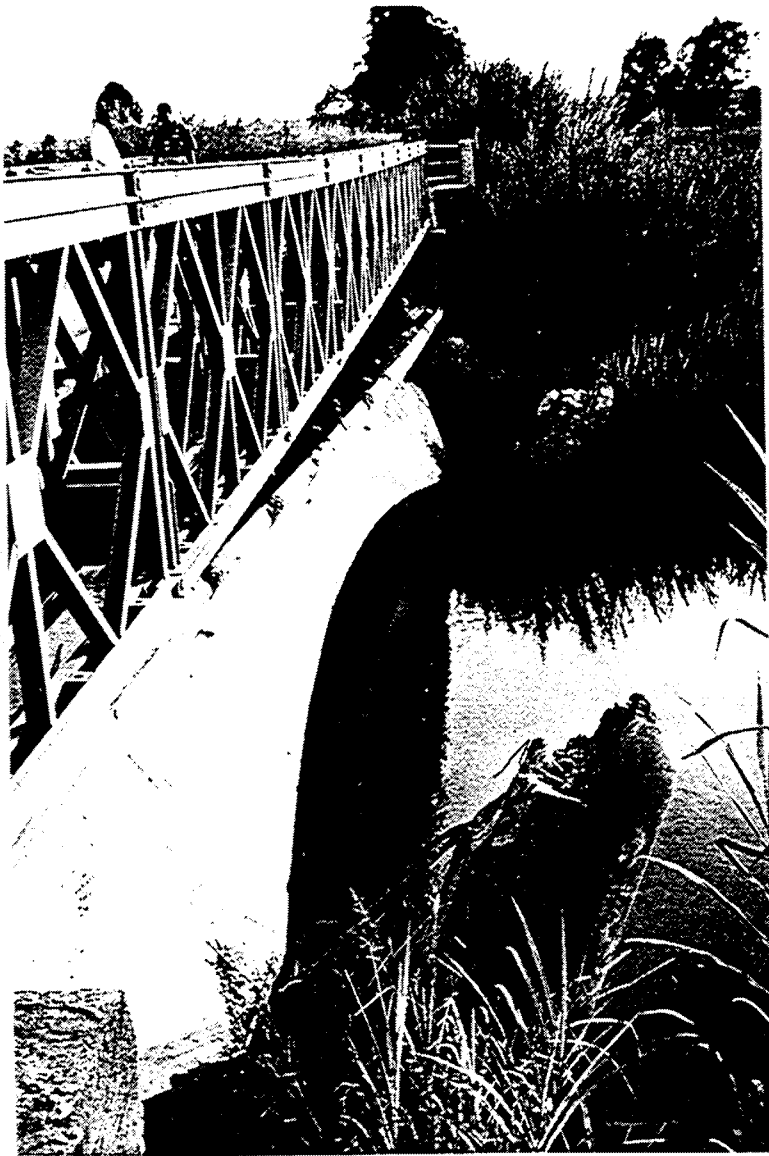
The bridges have mainly been built using the old abutments and piers whenever possible and after necessary repair. The old, destroyed superstructures have at many places been left in the rivers, at some locations in the Central corridor whole superstructures have been left tilted and obstructing the water flow in the river under the new bridges. At these locations dams can easily be formed during heavy floods causing risks of damage to the superstructures, piers and abutments. These old structure parts should be removed as soon as possible before any damage is caused to the new bridges.

**Huambo-Kuito**  
**Rio Cunhangamua**  
Destroyed bridge left  
in the river under the  
temporary bridge

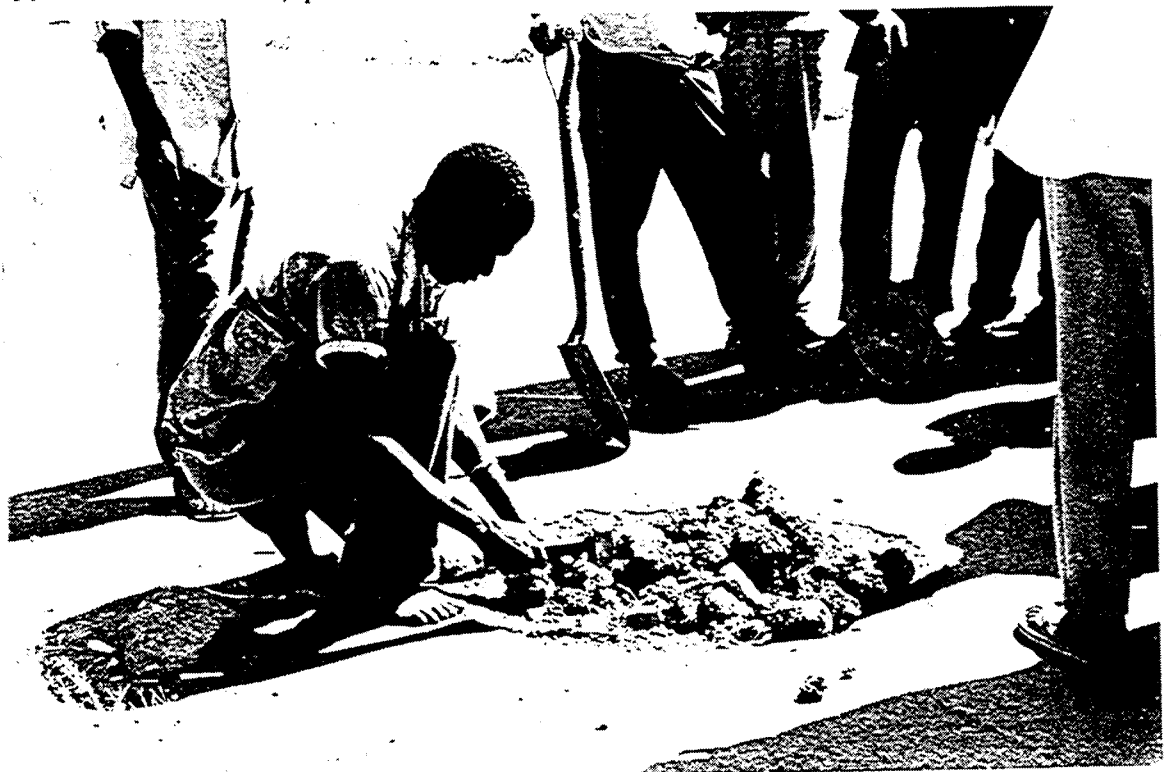
It was, however, observed that the repair of the potholes may not always have been repaired in accordance with given instructions or in accordance with normal practise. The final result of the pothole repair indicated that the holes may not have been cut straight or square in shape but circular. Furthermore, at many locations the surface of the repair was unnecessary high, much higher than existing road surface. The reasons may be related to lack of strict supervision or lack of knowledge and experience in pothole repair procedures. The lack of supervision may be explained by shortage of enough supervisory staff, and the incorrect or poor repair by inexperienced staff.

**Huambo-Kuito**  
Pothole repair carried out by locals.  
Commendable initiative, questionable standard of repair.

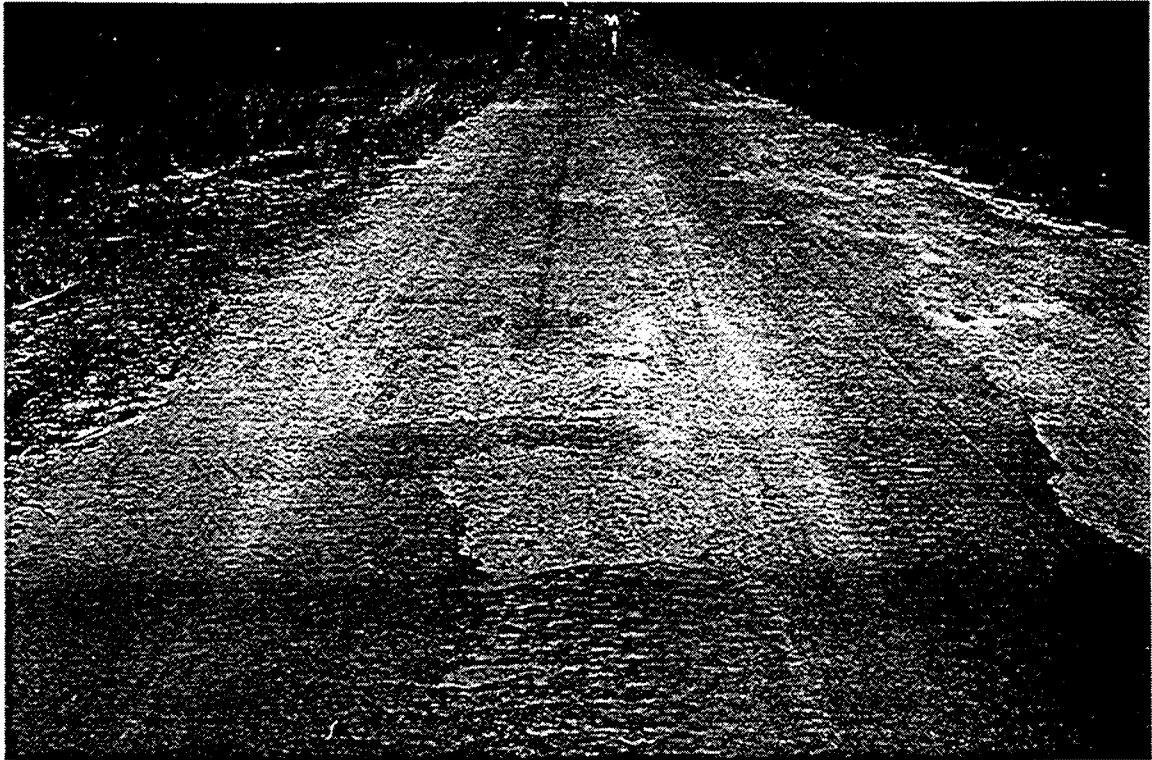
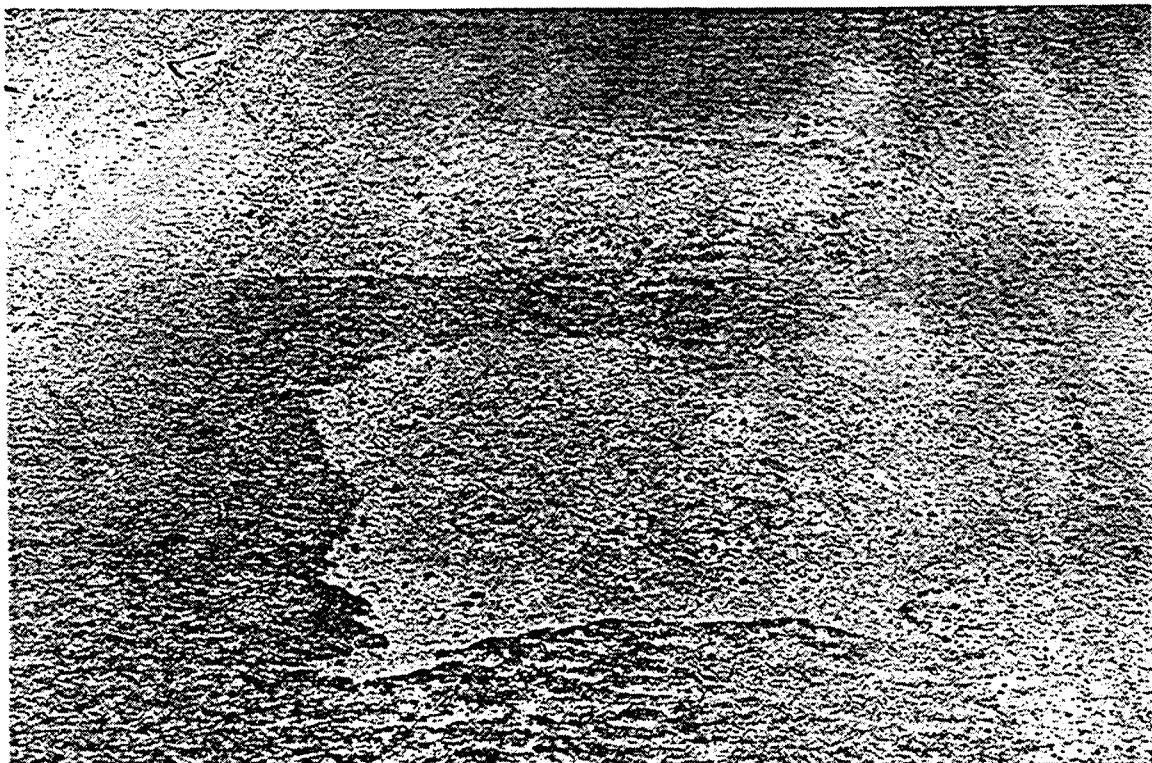
At several locations it was observed that the use of laterite as filling in potholes without emulsion and crushed stones has been successful. The repair has stayed intact and become very hard. This is probably due to the better quality of laterite with correct grading, plasticity and strength. It was also noticed that the exposed base layer in the pothole was of good quality, which is an indication of availability of good material in the area. Since materials from old gravel pits were used in the repair it is likely that suitable materials were extracted.

Successful pothole  
repair with laterite
