**SIDA Evaluation Report, Infrastructure, Sri Lanka**

# **THE KOTMALE ENVIRONMENT**

**A study of the environmental impact of the  
Kotmale Hydropower Project in Sri Lanka**

SIDA Evaluation Report 1989/1, Infrastructure, Sri Lanka

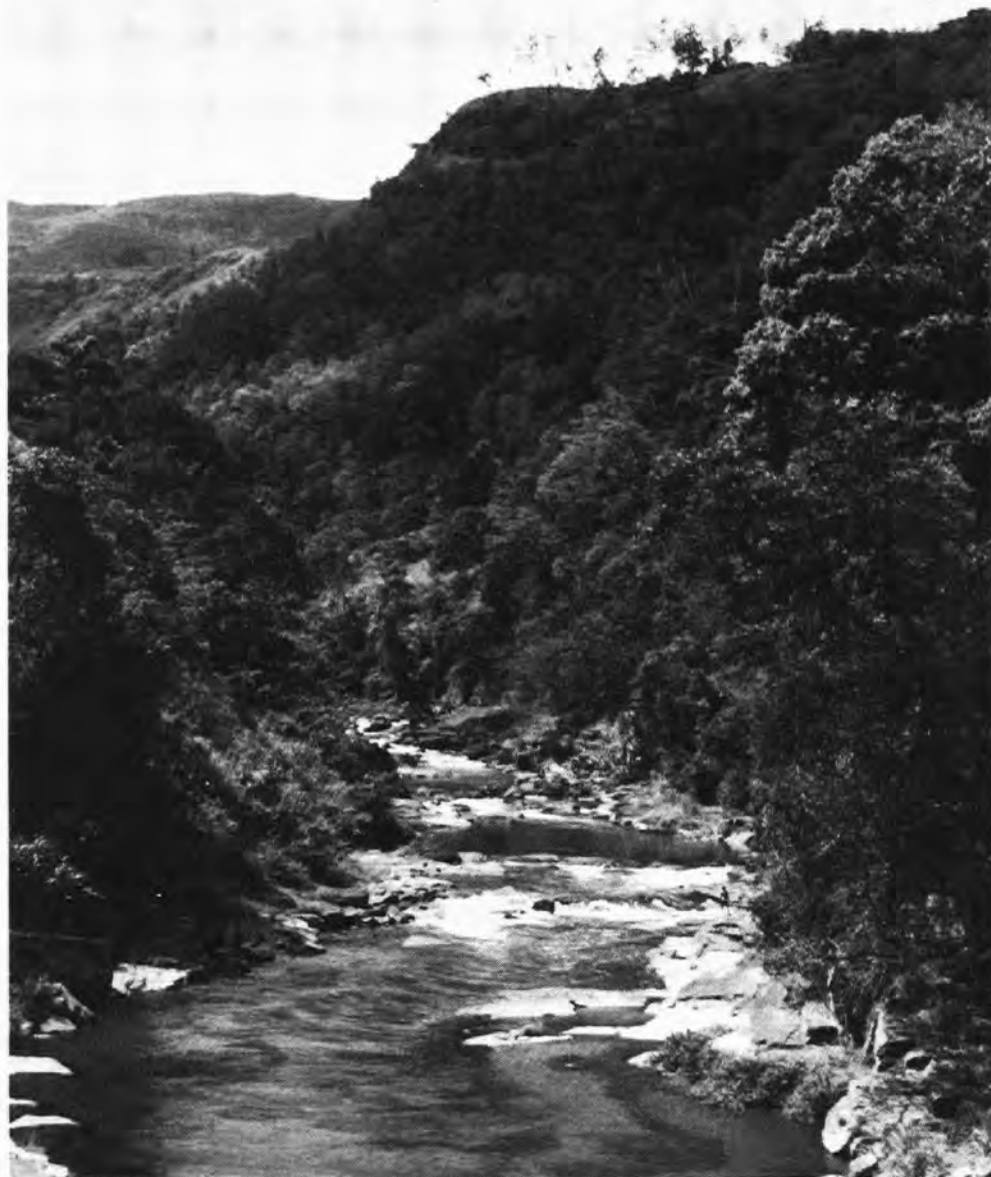
*1. The Kotmale River about 1 km upstream from the inflow to the Kotmale reservoir. In this section the river passes through a land system with deep narrow valleys and steep slopes, the latter covered by tea plantations or derived grass land. A narrow strip of riparian vegetation delimits the rocky river bed. There are numerous rapids and small waterfalls in this section, which keep the water entering the reservoir saturated with oxygen. The swift flow of the river, especially during peak flow, suppresses the development of rooted aquatic or semi-aquatic vegetation.*

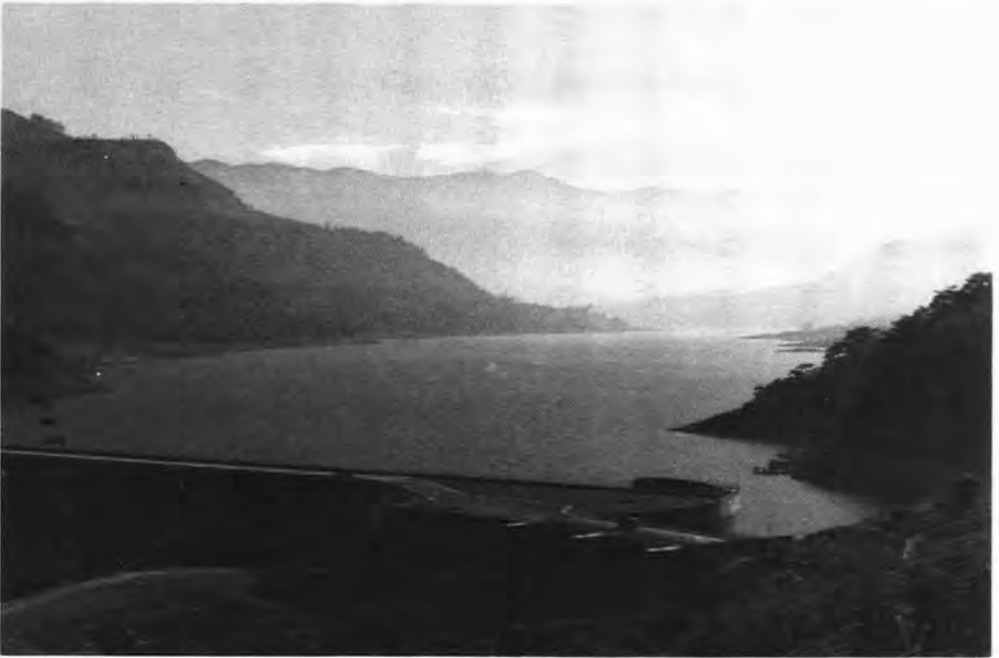
2. Kotmale reservoir at the damsite, January 22, 1988.

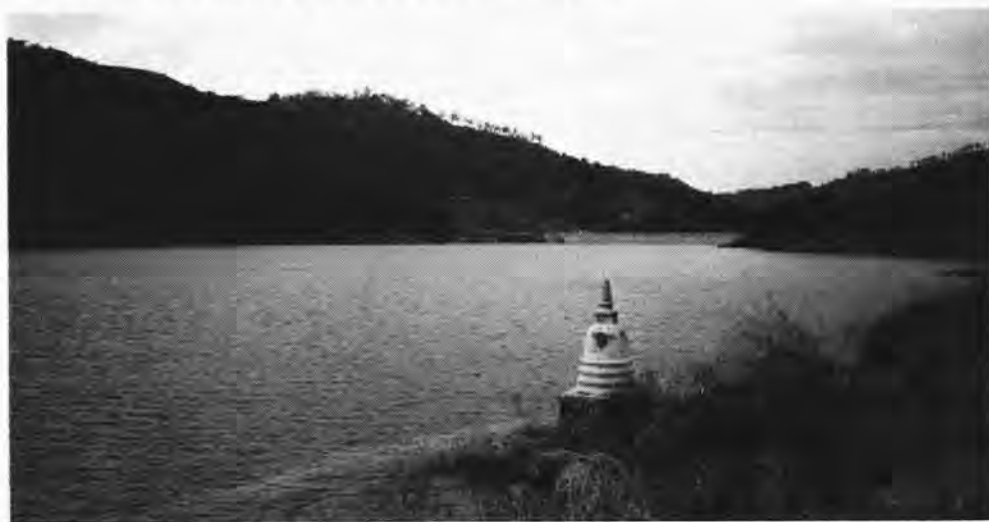
3. Some objects and sites of a cultural or religious nature were flooded. The remains of a temple appear at the draw-down of the reservoir surface. January 16, 1988.

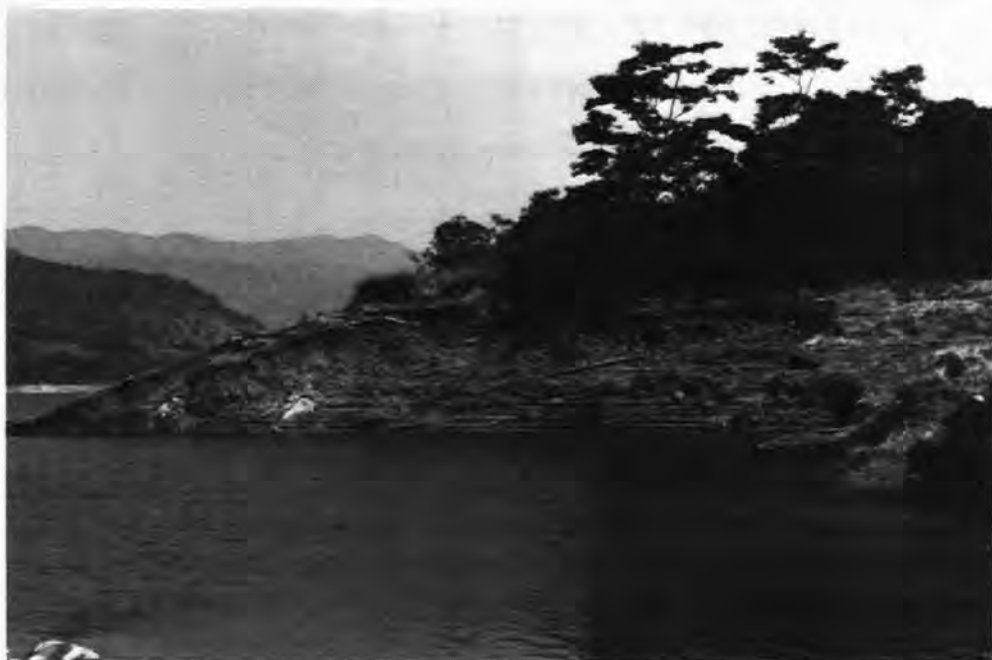
6. A steep shore with slip scars. Southern shore, about 400 metres from the dam, January 22, 1988.

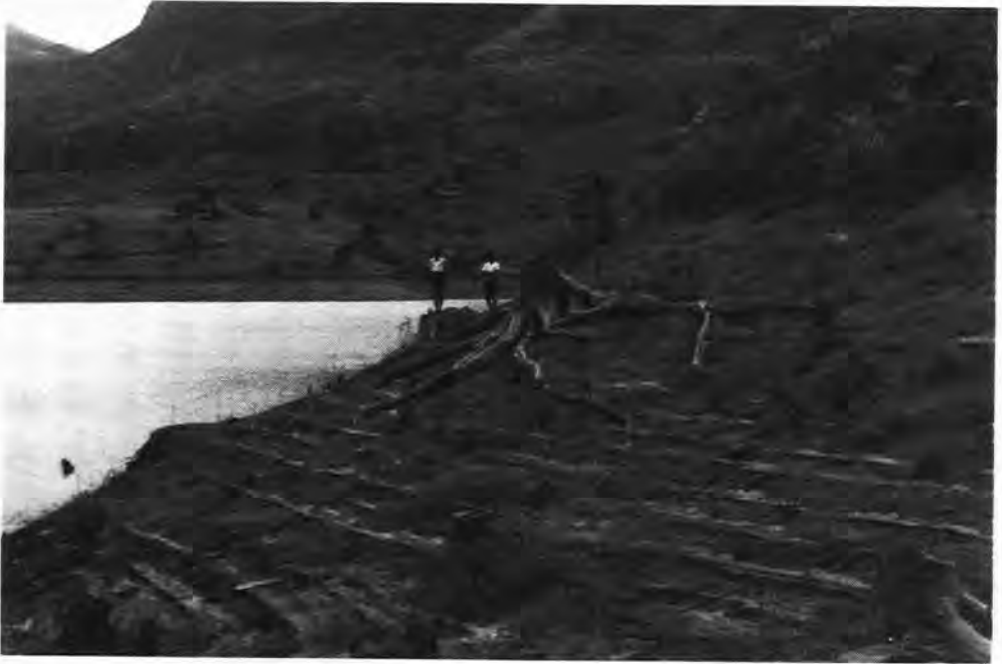
*7. A rather steep section of a shore near Muslimgama. Abrasion has removed a layer of the topsoil exposing the root system of the felled trees. Coarse sand washed out by the waves is deposited in thin parallel stripes reflecting different levels of reservoir draw-down. January 15, 1988.*

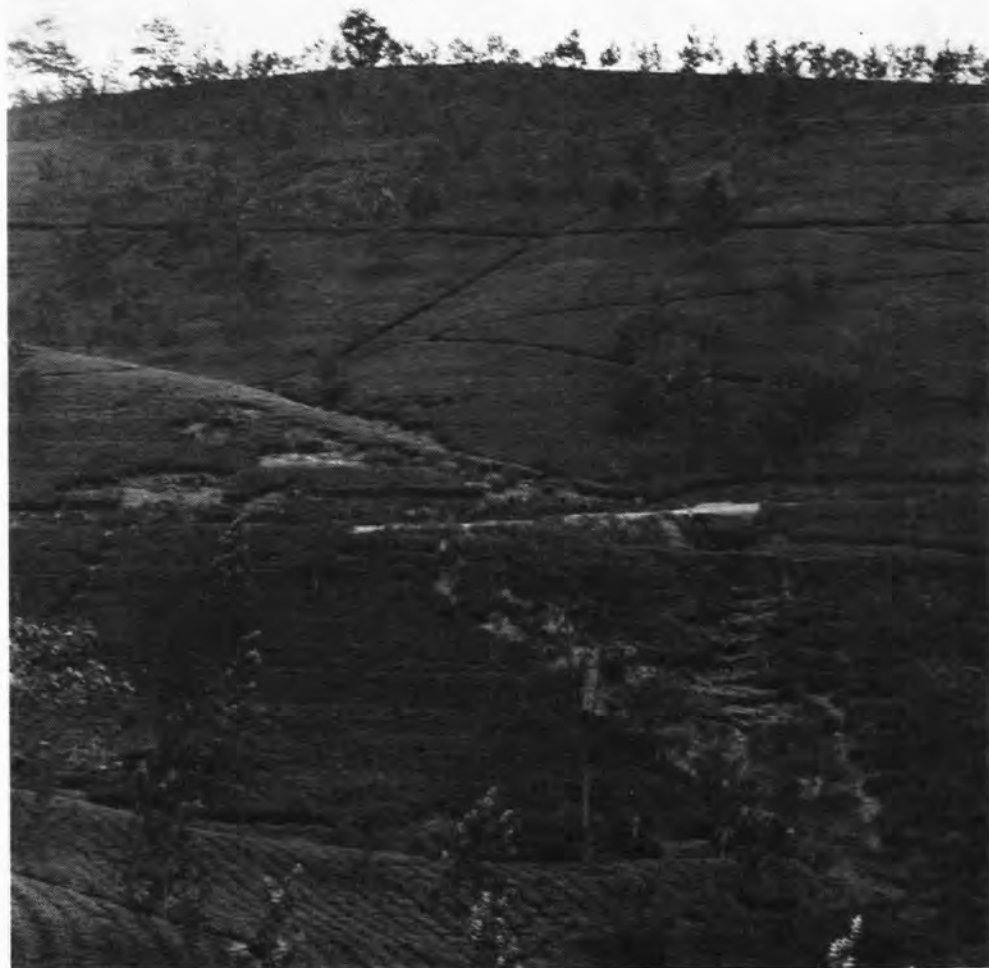
*11. Erosion in tea plantation at the Rothschild tea estate on the northern slopes of the reservoir. January 16, 1988.*

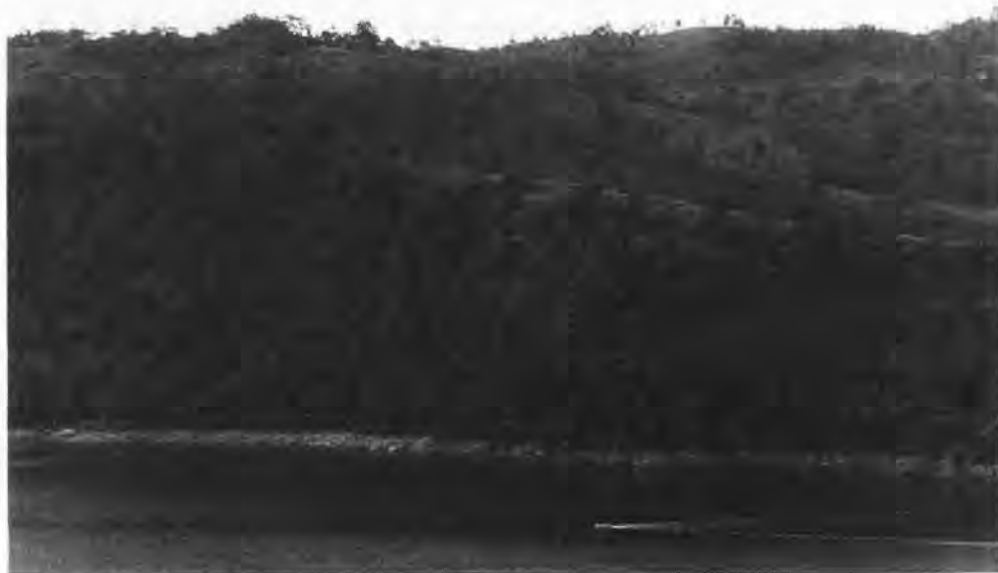
*13. Rock ledge on the southern shore of the reservoir near the damsite.*

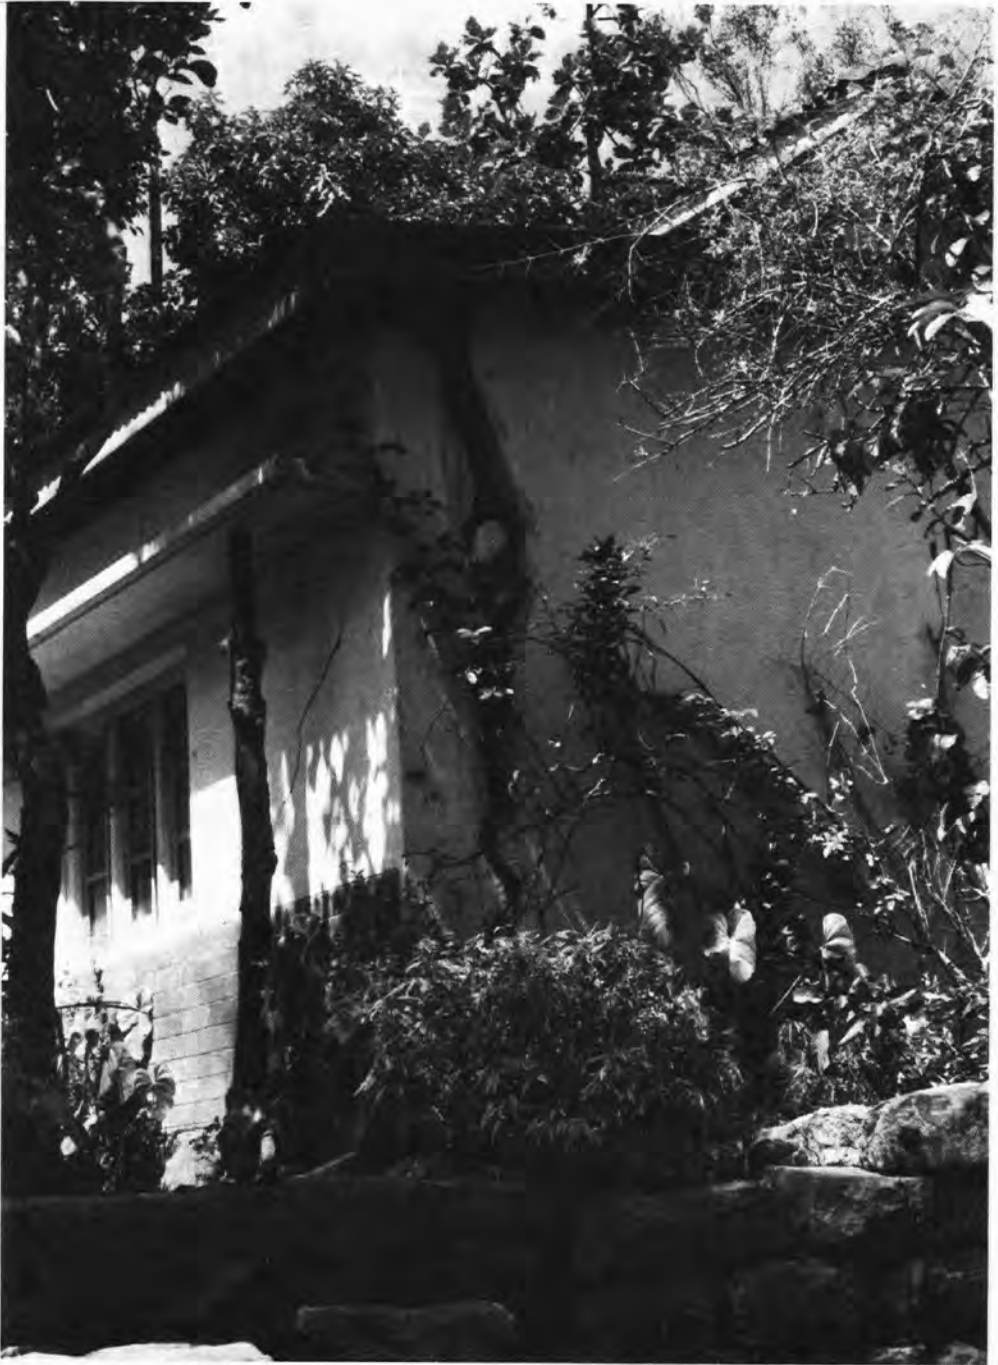
*14. Deep cracks across the wall and floor of a house at Wataddora, January 17, 1988. The cracks run parallel to the slope and the reservoir shore line.*

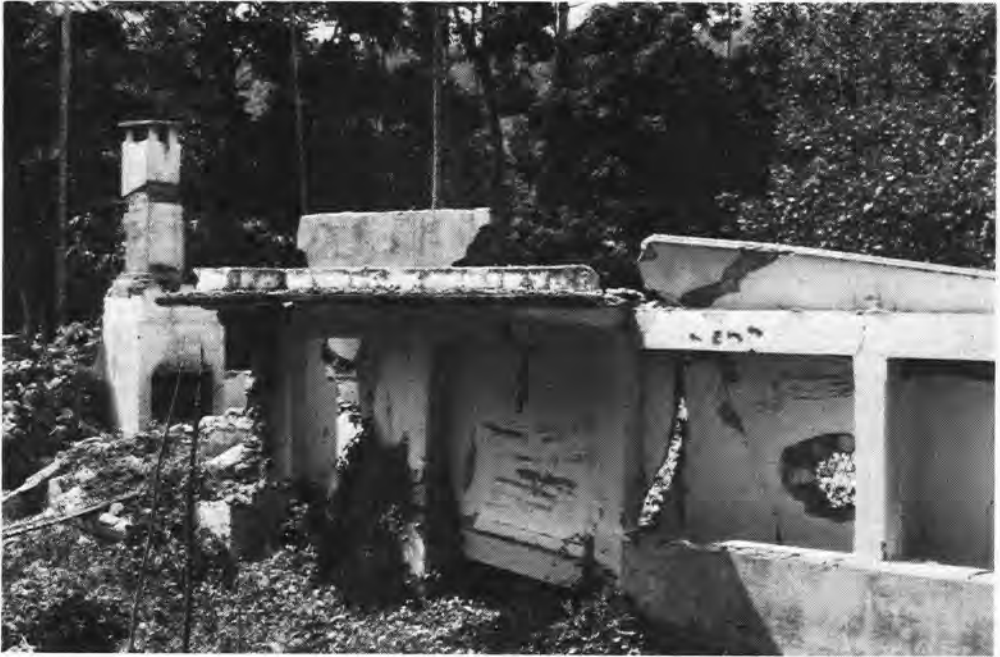
*16. Collapsed house at Pahalagammedda, Niyangandora. The damage is stated to have occurred in 1986. This area is badly affected by slides and soil creep, and all houses werw abandoned by January 19, 1988.*

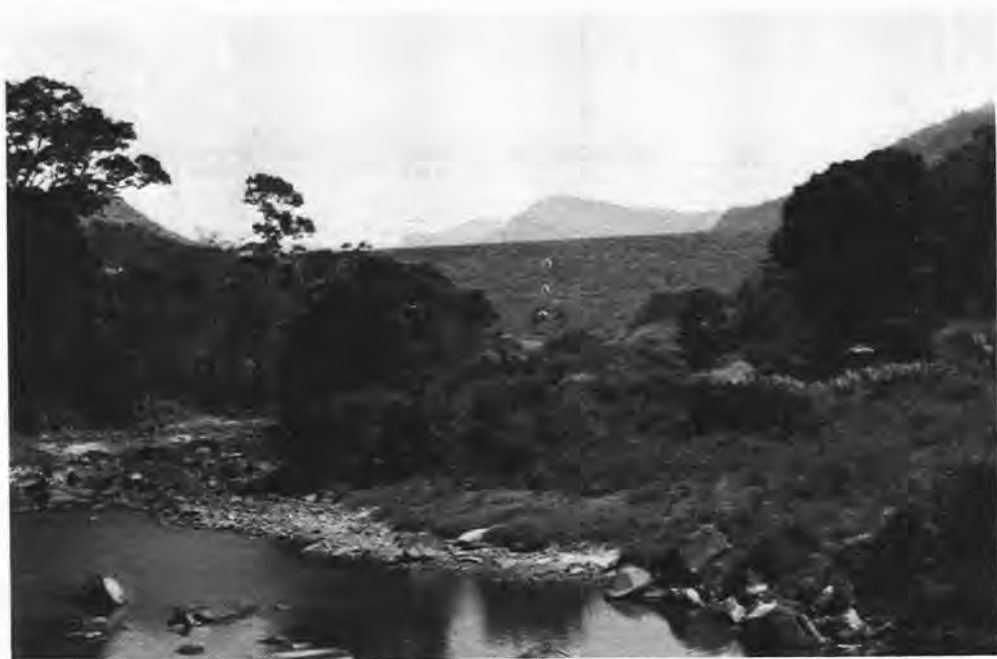
17. *The river-bed a short distance below the Kotmale dam. January 22, 1988.*

First of all, a long stretch of rapids have disappeared with the particular aquatic life associated with this type of habitat. Instead there is a minor stream (at least in the dry season) of clear water flow between rocks and boulders devoid of periphyton (attached aquatic vegetation). The environment gives a sterile impression

reflected in the paucity of animal life (Picture 18). Three species of birds only, the Grey Wagtail, *Montacilla cinerea melanope*; Pallas, the Grey- Headed Yellow Wagtail, *Montacilla flava thunbergi*; Billberg, the Common Sandpiper, *Acitis hypoleucos*; Linn, were observed in this habitat and only occasionally and in well spaced-out territories.

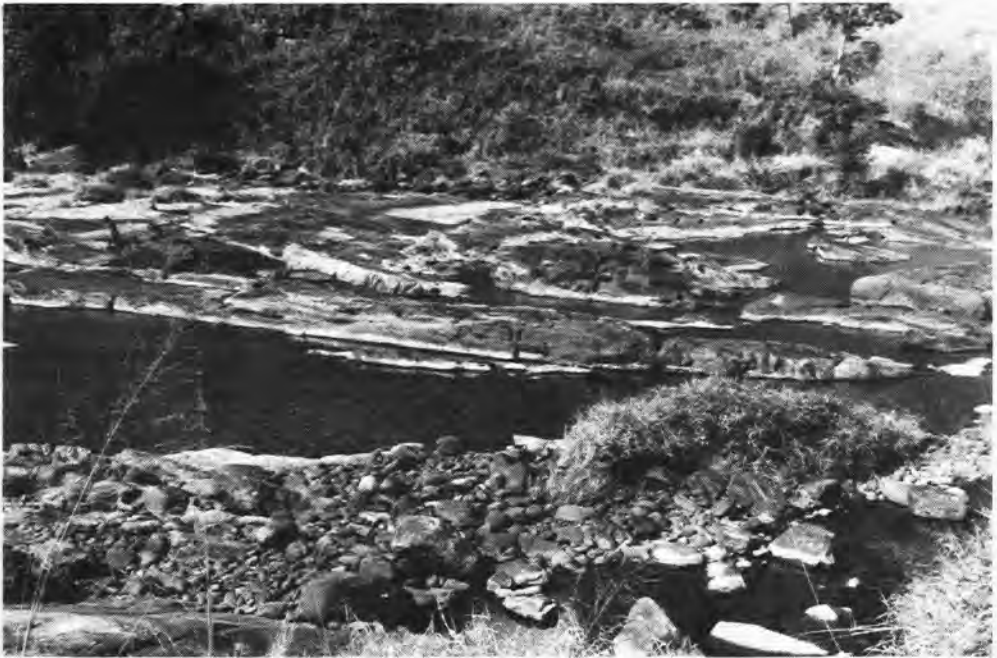
18. *The river-bed near Mawatura, approx. 3 km downstream of the Kotmale dam. January 20, 1988.*

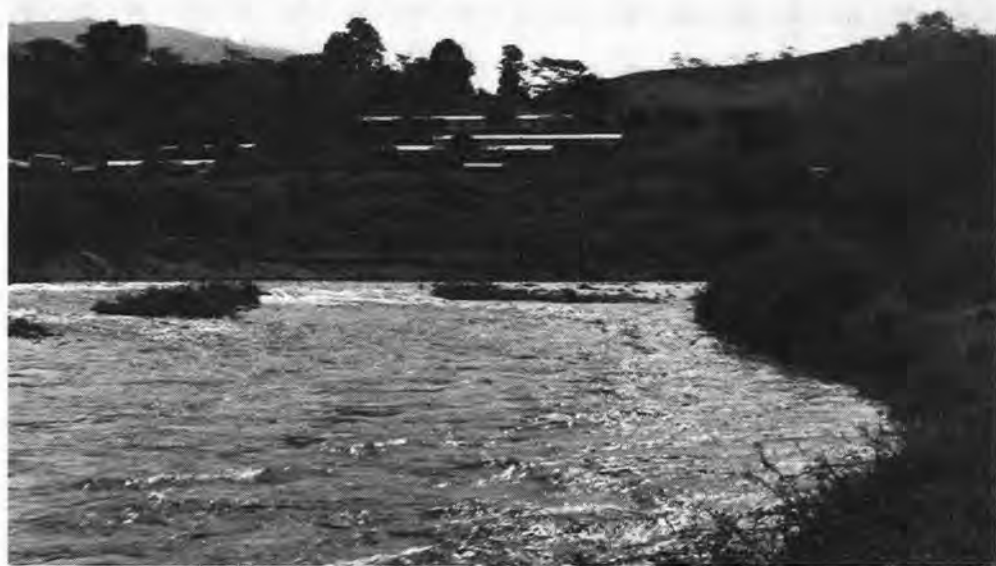
19. *The tailrace canal.*

The water released through the tailrace canal contains very little silt, the bulk of which has been deposited in the reservoir. This means that the silt-carrying capacity of the water increases, i.e. the clear water discharge has a high erosion potential. An open about 100 metres long erosion scar, in old river sediments, occurs on the right bank of the canal near the inflow into the Mahaweli Ganga.

The erosion capacity is rapidly diminished after the confluence with the Mahaweli Ganga, which is loaded with silt from upstream areas.

However, some impact by erosion in the river-bed and on the river banks can be anticipated.
